Appendix F

Structures Inspection Results

FACILITIES CONDITION ASSESSMENT REPORT

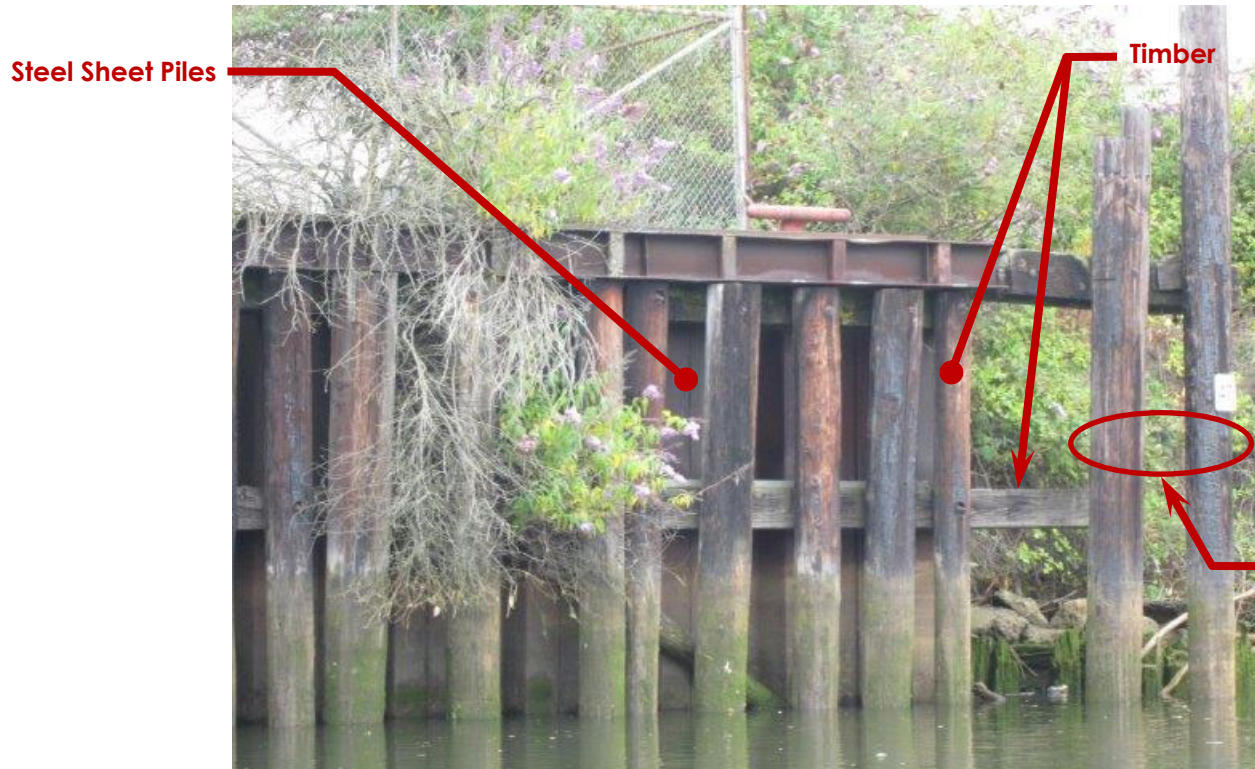
Photo ST03-18: Hybrid Bulkhead (south end)

- Steel sheet pile bulkhead with timber fender pile (Photo 18).
 - Timber piles and lagging (Photo 19 to 25).
- Close observation was conducted where possible. However, except for the two relatively new segments of steel pile bulkheads (Photos 2, 6, and 7) which appear to be in good condition, the remainder of the bulkhead segments are in various states of indetermination.

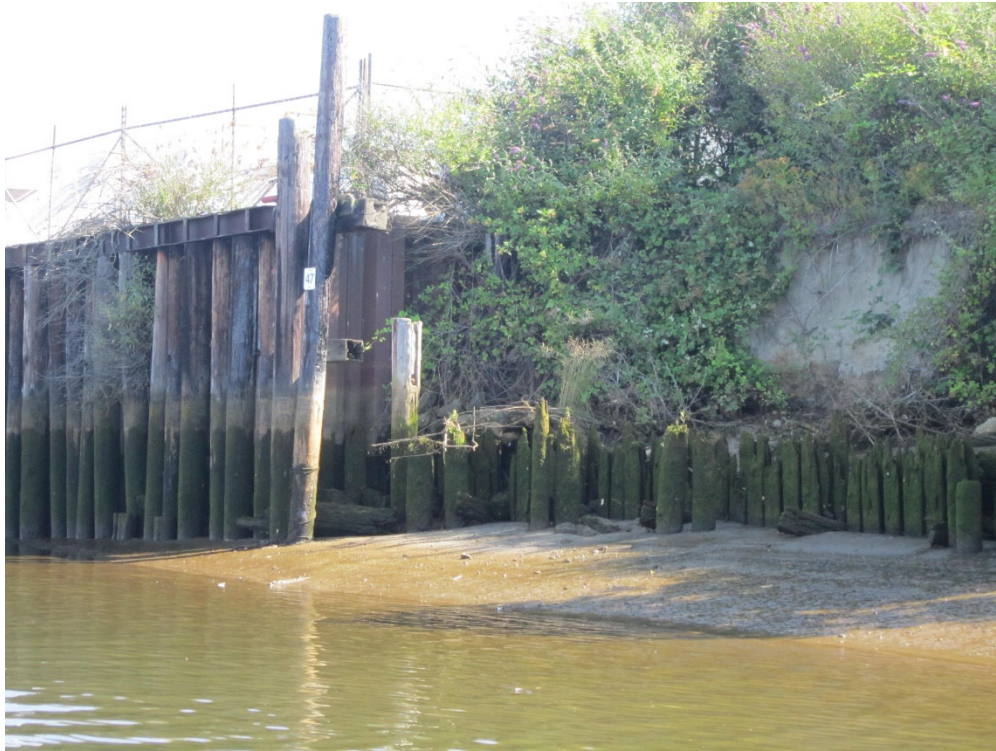
Photo ST03-19

- In the bank, protection consists of closely spaced timber stub piles with timber lagging behind the piles (Photos 19 to 25).
- The tops of the piles are generally rotted or splintered, but the lower sections appear sound (Photos 20 to 25).
- Lagging in a number of areas are rotted and soil erosion through the bulkhead was observed (Photos 22 to 25).
- Pile embedment and the condition below mudline are not known.

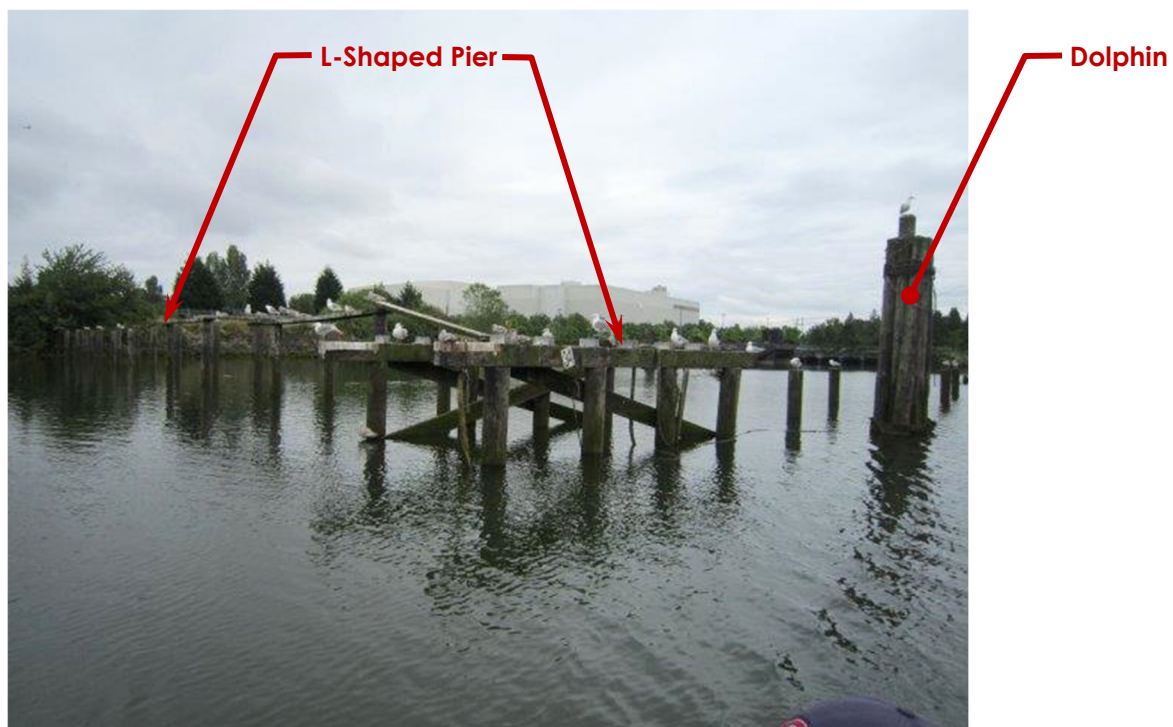
- L-shaped pier of two (2) treated timber pile bents – One (1) leg extends west from the shore and the other offshore leg extends to the south (Photos 1 to 4).
- The pier is delapidated and not in use – Several piles are missing or broken. Decking and cross bracing members are missing.

- Along the south and west side of the pier are several 7-timber treated pile dolphins; some are missing piles. The dolphins are still in use (Photo 1, 2, and 5).
- The cluster of piles are strapped together with a combination of fiber and/or strand wire rope. Some straps are broken or missing (Photos 5 and 6).
- Some piles are eroded and have lost material thickness. However, the core appear to be sound (Photo 7).

Photo ST04-01: L-Shaped Pier and Dolphins (Looking South)

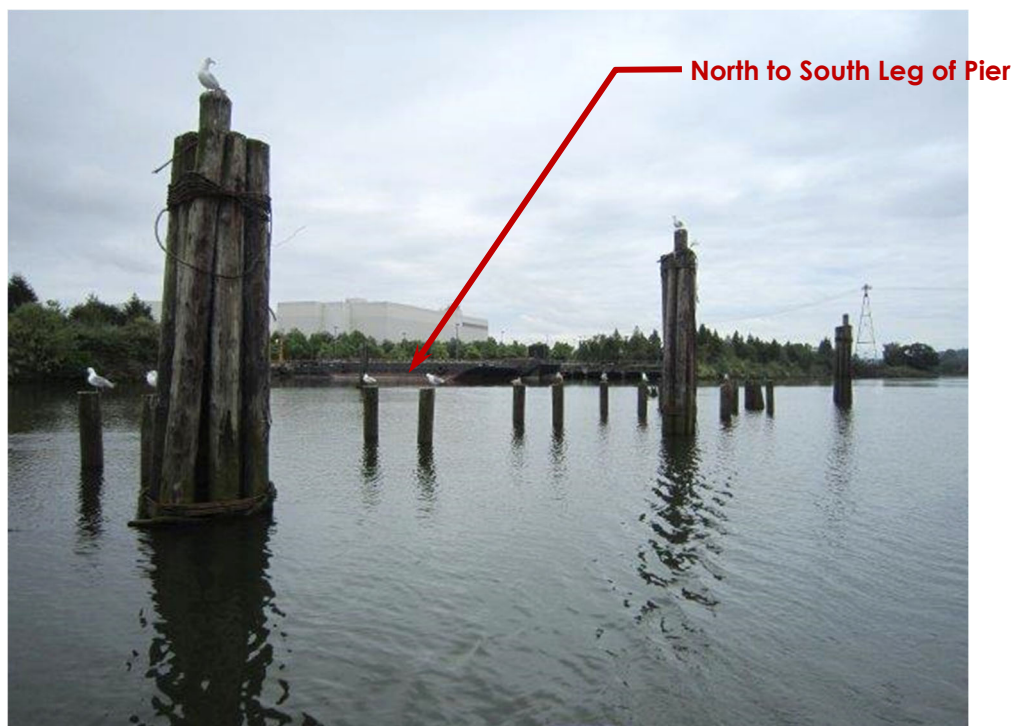
Photo ST04-02: L-Shaped Pier and Dolphins (Looking South)

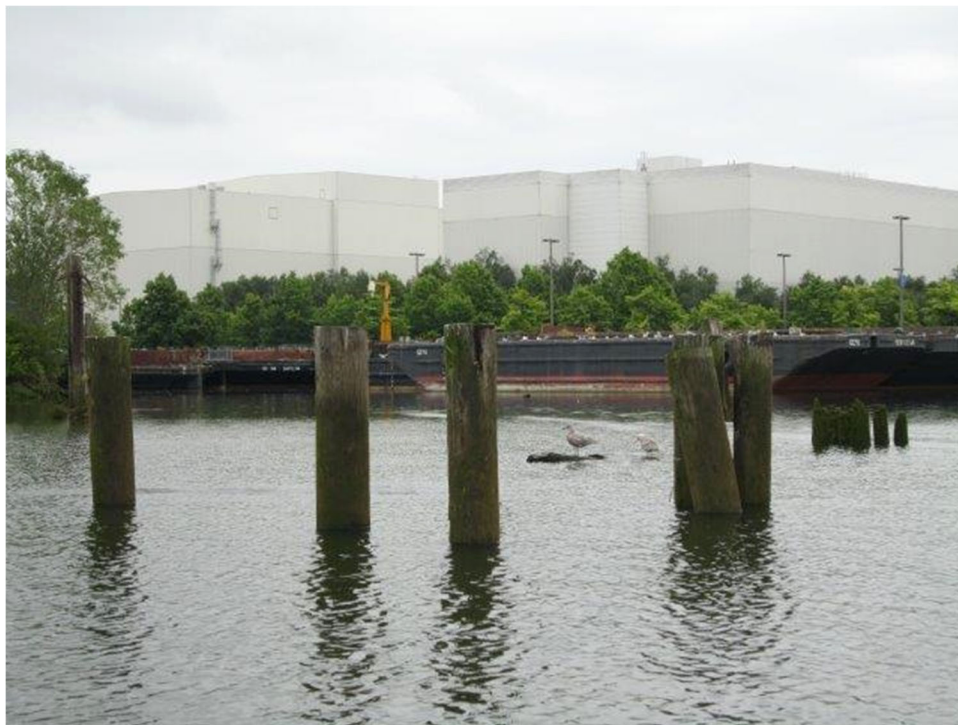
Photo ST04-03: South End of Pier

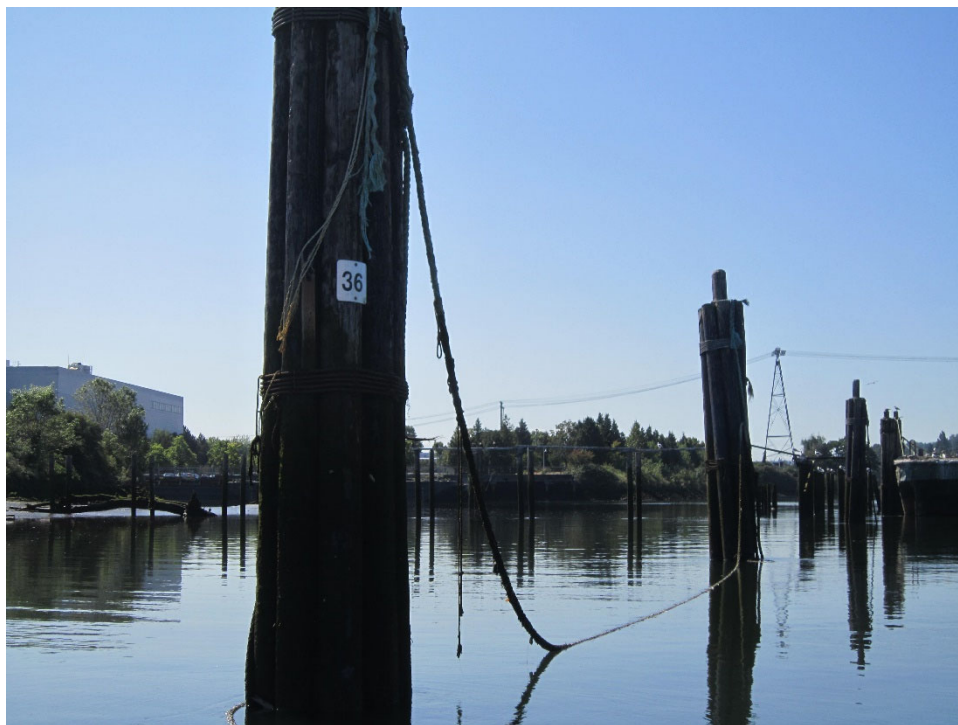
Photo ST04-05: Dolphins

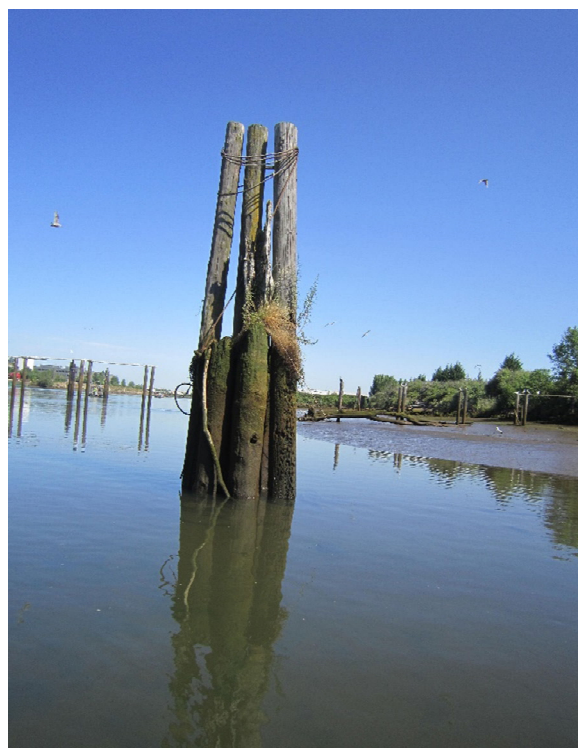
Photo ST04-06: Dolphin

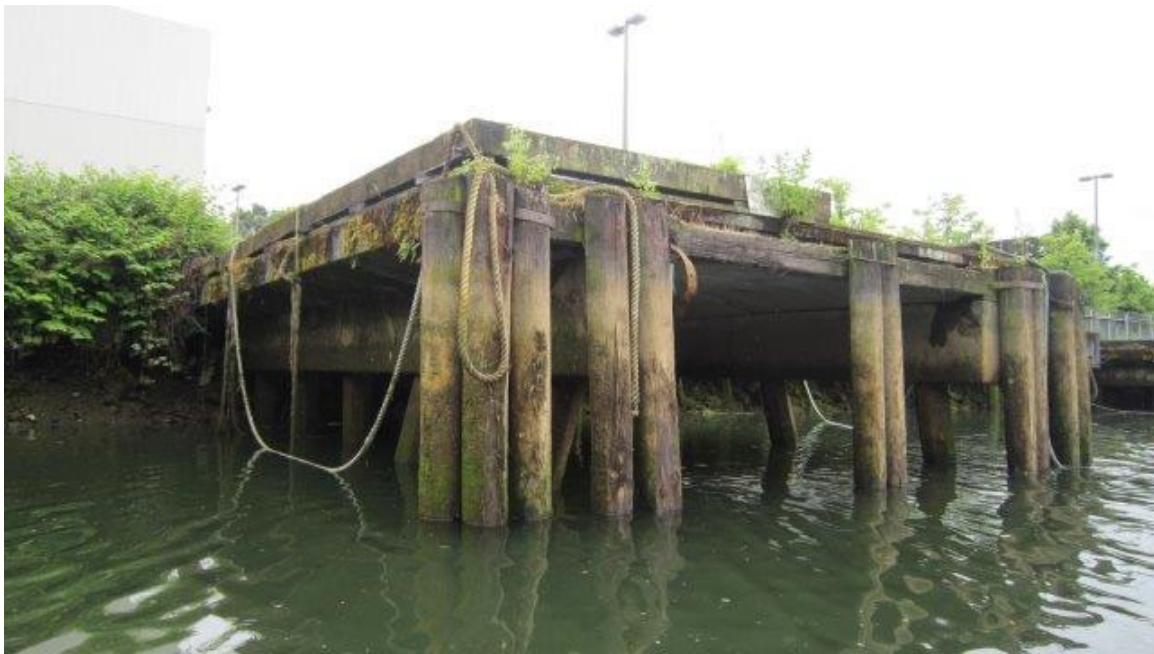
- The timber fender piles are generally intact except for the loose or missing straps. (Photos 1 and 2) The top of the piles appear to be rotted due to weather exposure and subsequent vegetation growth. The body of the piles within and above the splash zone appear to be sound and in good condition. Pressure treatment appears to be in good condition.

Photo ST05-01: Pier 1, East Most (Looking Southwest)

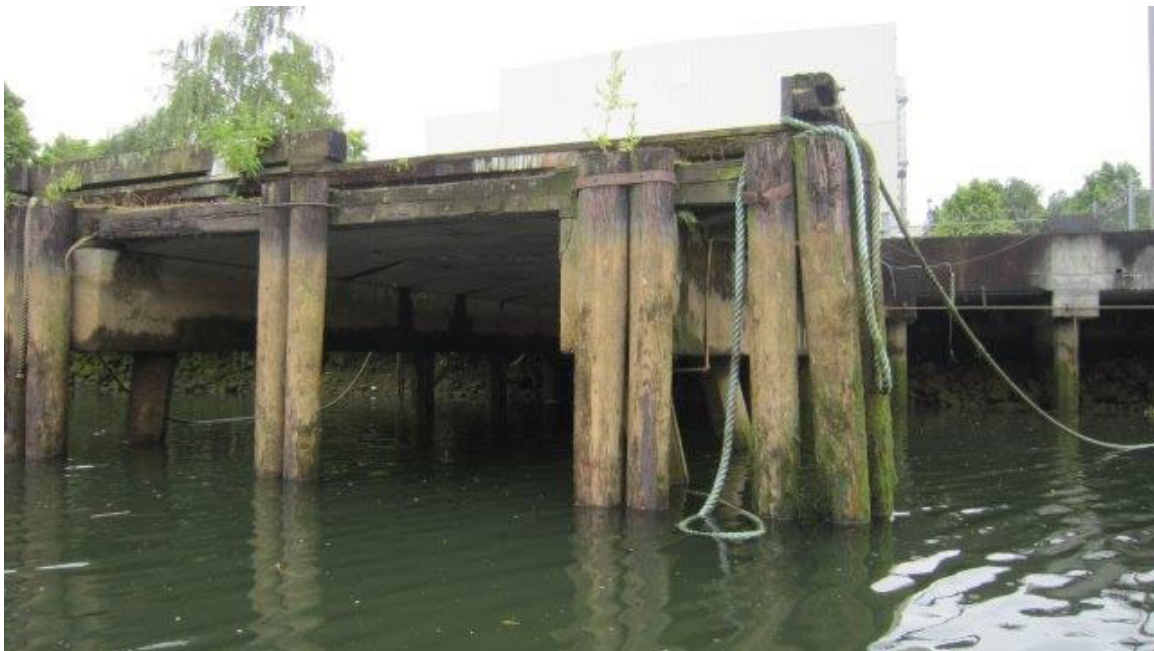
Photo ST05-02: Pier 1 (Looking South)

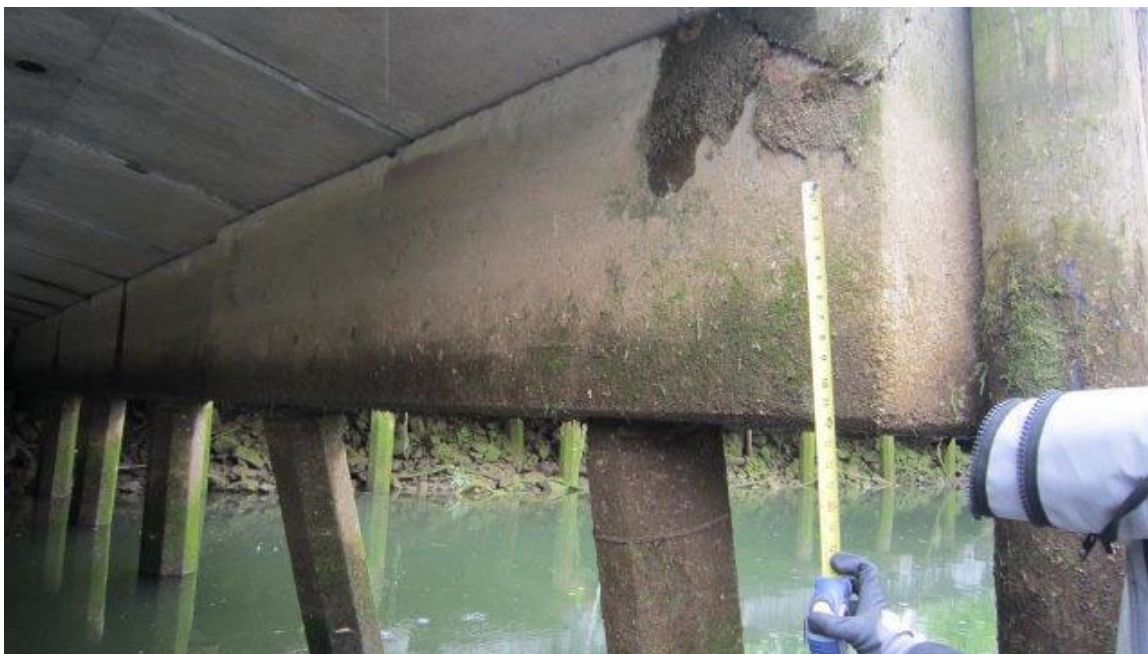
- The concrete piles are in good condition except for mortar surface erosion in the wet/dry zone of the piles (Photos 3 and 5).
- Along the length of the lower part of the pile cap is a crack. This is typical on all pile caps. (Photo 5)
- The pile caps are in good condition except for a loose concrete spall on the east face near the top of the cap and (b) mortar surface erosion in the splash zone (Photos 3 and 4).
- Pier decks are in good condition except for corrosion of exposed reinforcing bar in one of the panels (3rd panel from the north) and some rust stains between the 4th and 5th panel (Photos 6 and 7).

- a) Falling debris hazard due to loose concrete spall (Photos 3 and 4).
- b) Rot and decay at top of fender piles.
- c) Loose fender pile straps.
- d) Snag hazard due to loose mooring lines.

Photo ST05-03: Pier 1, East Side of West Pile Cap

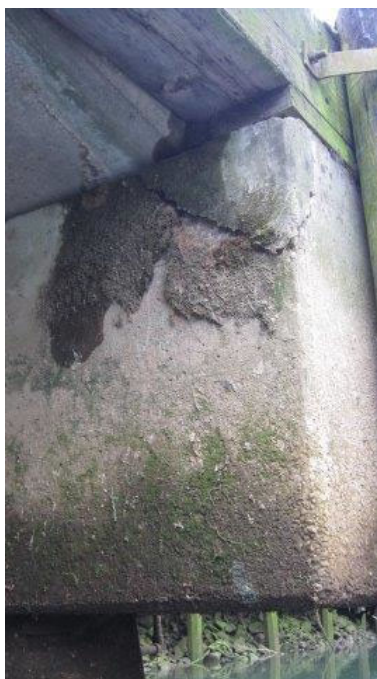
Photo ST05-04: Pier 1, East Side of West Pile Cap

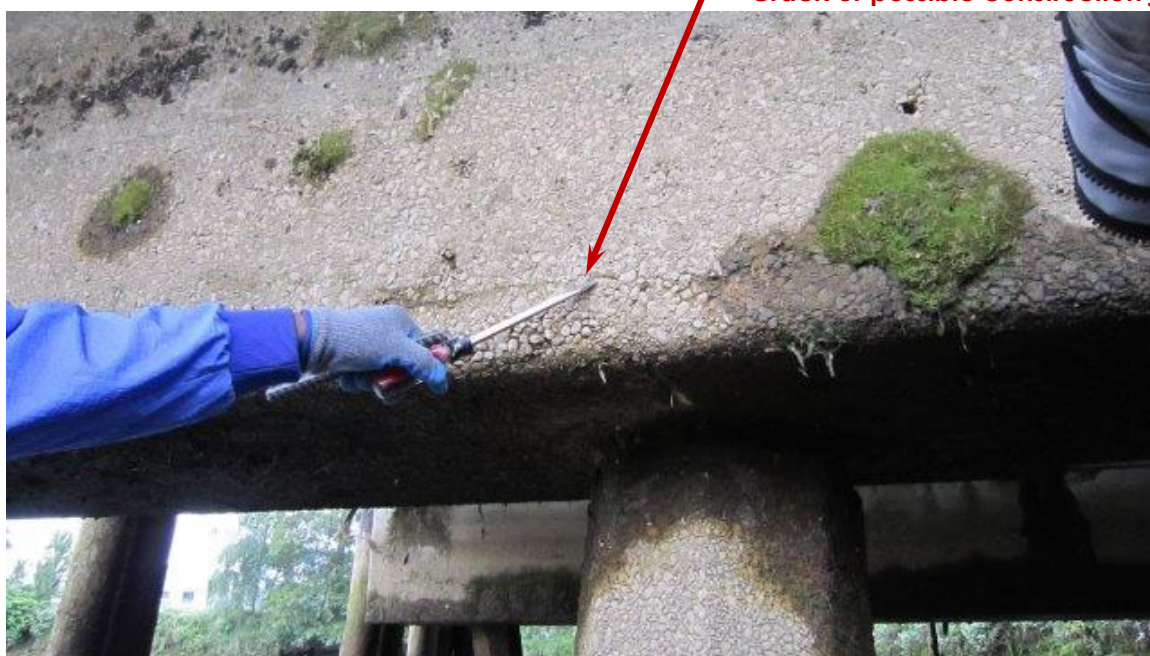
Photo ST05-05: Pier 1, West Side of West Pile Cap

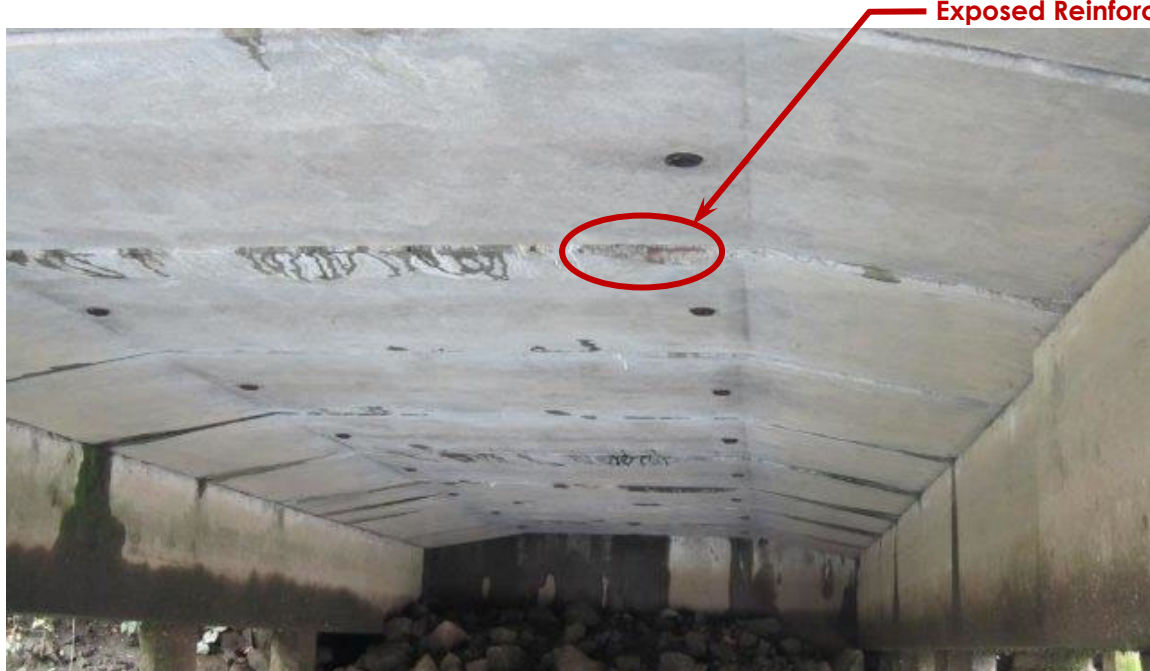
Photo ST05-06: Pier 1, Pier Deck Soffit

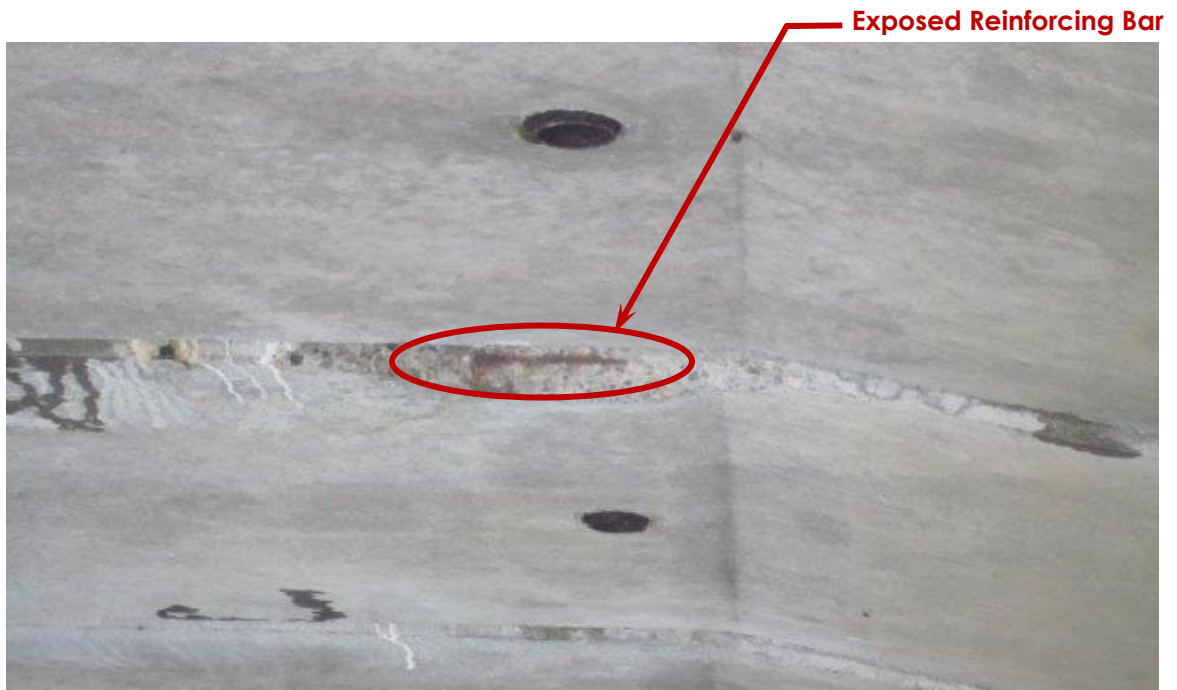
Photo ST05-07: Close Up of Exposed Reinforcing Bar

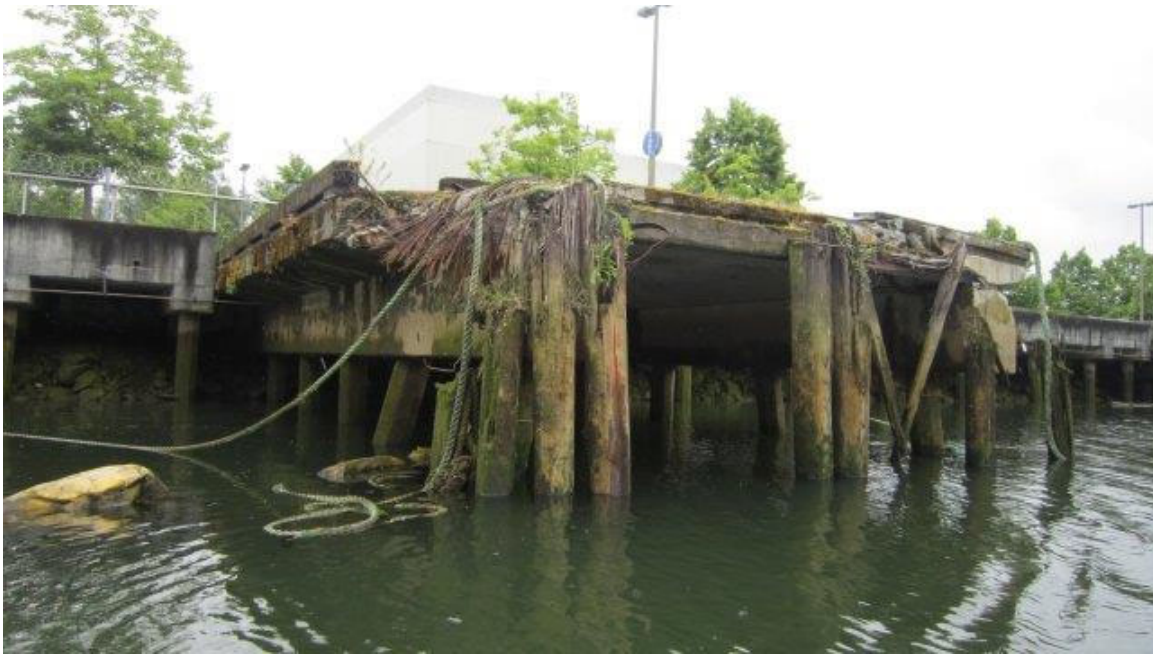
- Several timber fender piles are missing, broken, damaged, or missing straps. (Photos 9 and 10) The tops of the piles appear to be rotted due to weather exposure and subsequent vegetation growth. The body of the piles within and above the splash zone appear to be sound and in good condition. Pressure treatment appears to be in good condition.
- The concrete piles are in good condition except for mortar surface erosion in the wet/dry zone of the piles.
- The cap beams are in good condition except damage to the top of the west cap that exposes some reinforcing steel (Photos 10 and 11).
- The pier decks are in good condition except for portion of the west side of the first concrete deck panel is broken or partially demolished exposing some reinforcing bars (Photos 12 and 13).

- a) Falling debris hazard due to loose and damaged concrete of the pier deck and the top of deck (Photos 9, 12, and 13)
- b) Snag hazard due to loose mooring lines (Photos 9 and 10).
- c) Unprotected end of exposed reinforcing steel (Photo 11).
- d) Loose fender pile straps.
- e) It is not known if stub of missing piles exist above mud line.

Photo ST05-09: Pier 2

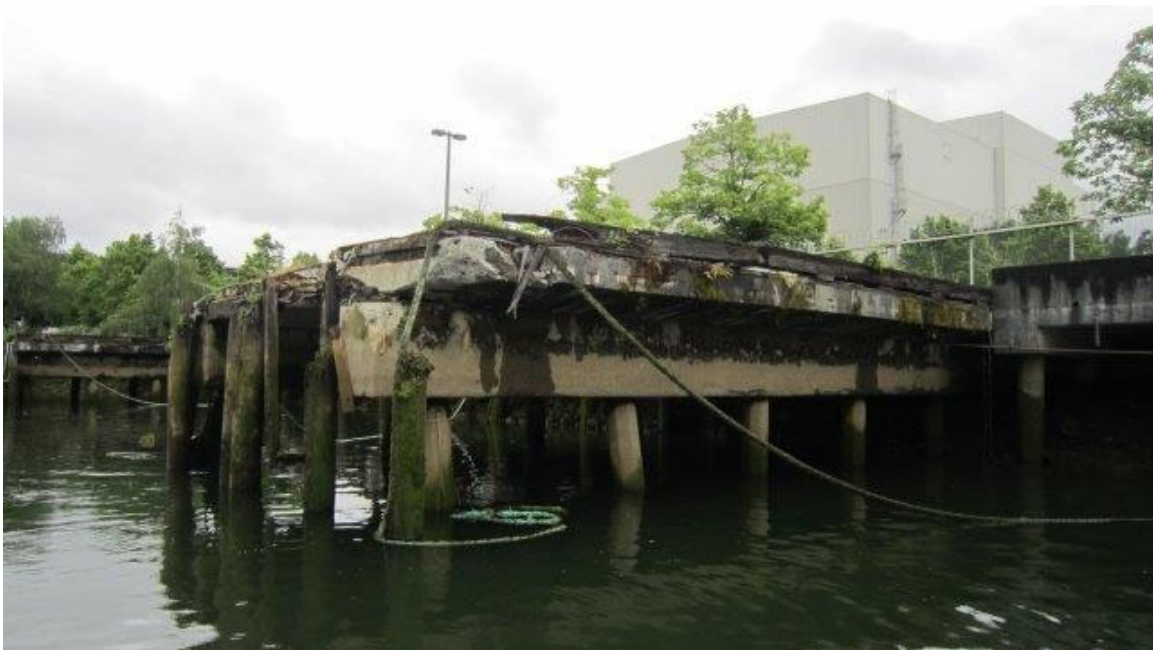
Photo ST05-10: Pier 2 (Looking Southeast)

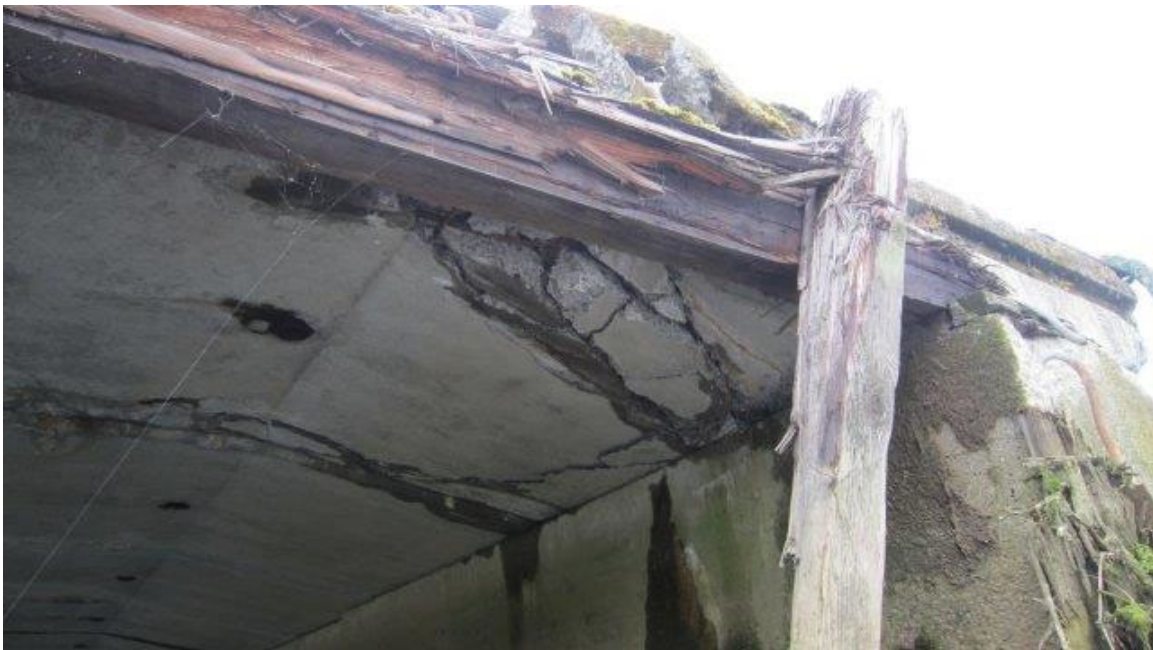
Photo ST05-12: Pier 2, Top West Corner of 1st Deck Panel

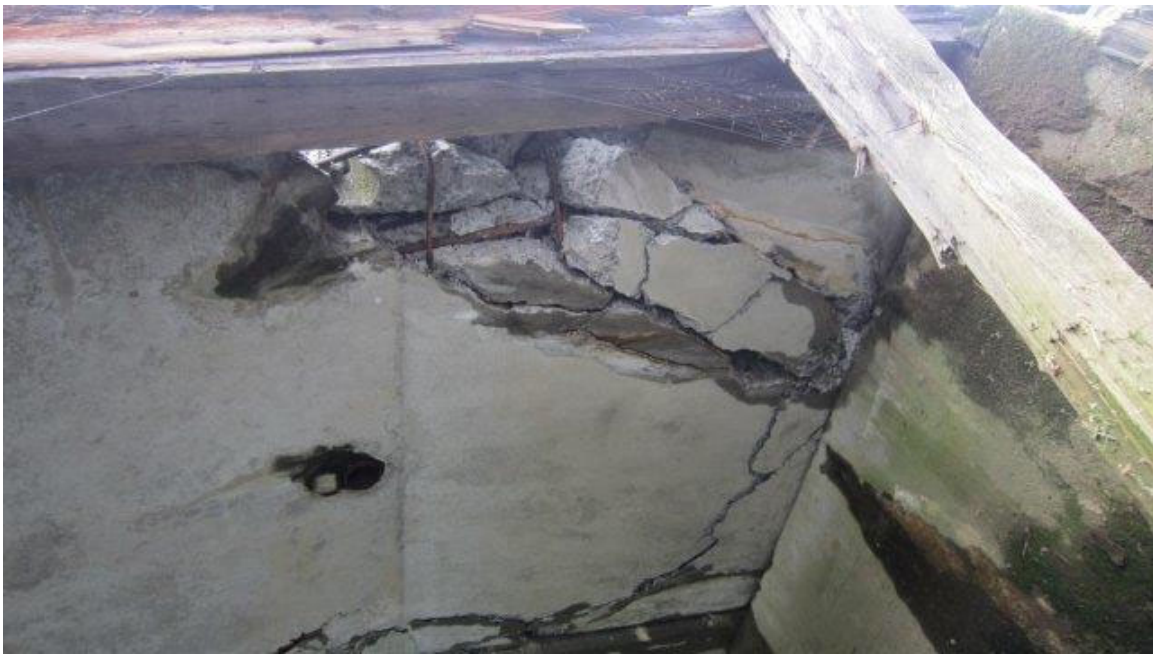
Photo ST05-13: Pier 2, Close Up of West Corner of 1st Deck Panel

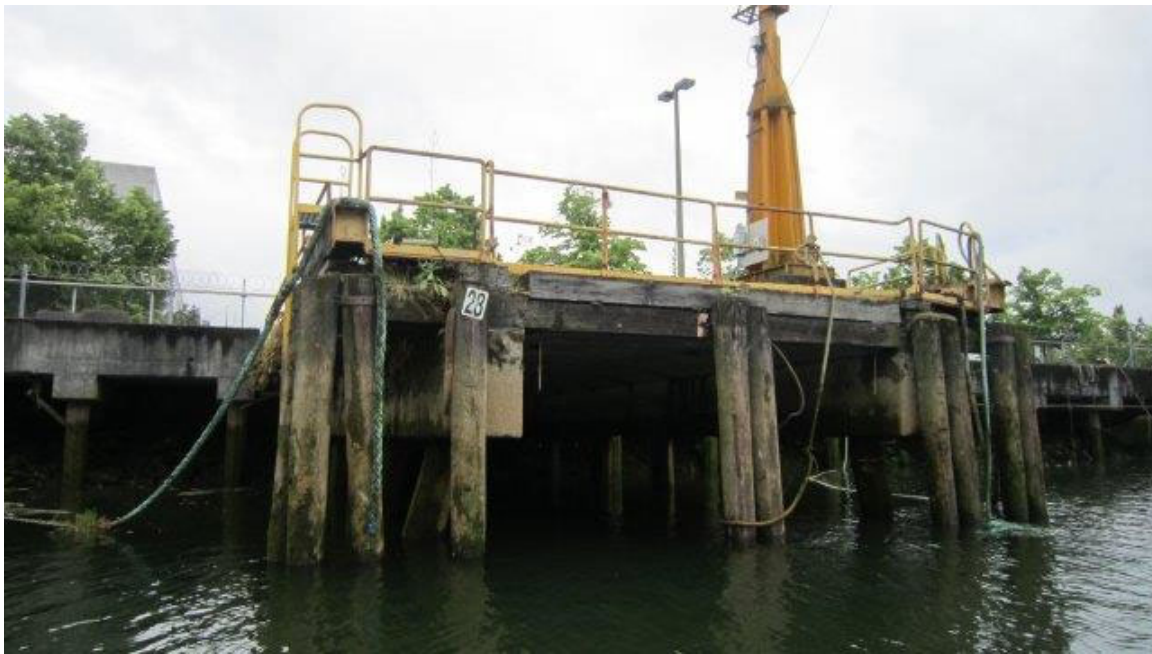
- A few timber fender piles missing with some loose or missing straps. (Photo 19) The tops of the piles appear to be rotted due to weather exposure and subsequent vegetation growth. The body of the piles within and above the splash zone appear to be sound and in good condition. Pressure treatment appears to be in good condition.
- The concrete piles are in good condition except for mortar surface erosion in the wet/dry zone of the piles.
- The pile caps are in good condition except for the pile caps are approximately 32" wide x 42" deep and the depth of the west cap over the first pile is deeper than typical.
- Concrete pier decks are in good condition (Photo 20).

Photo ST05-19: Pier 4

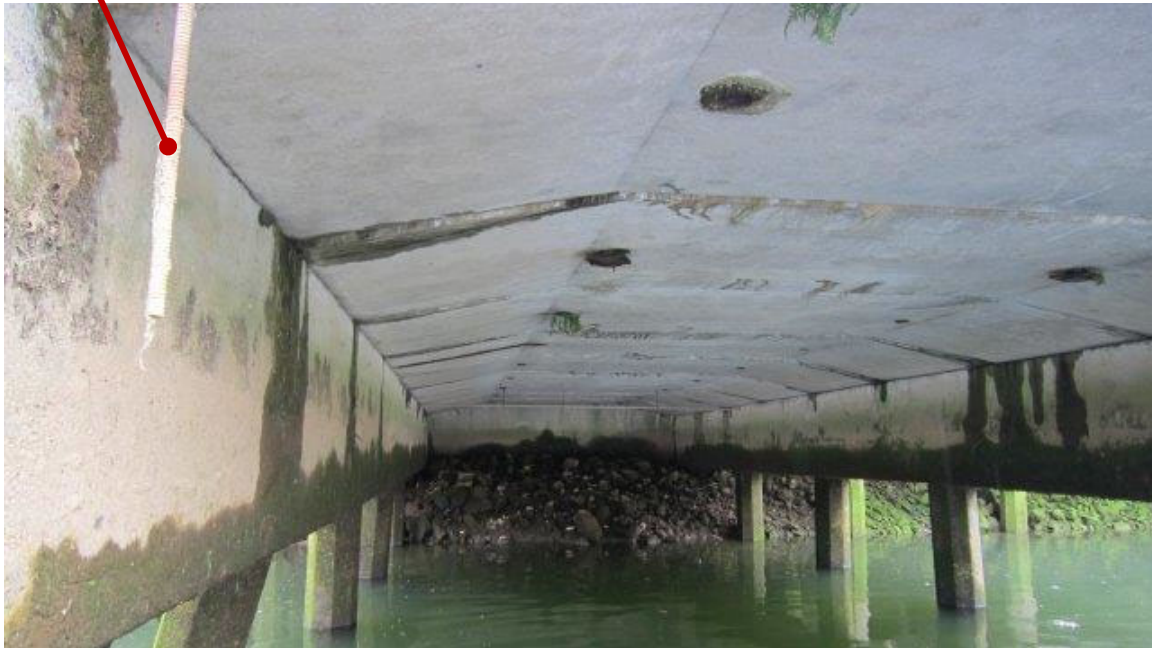
- a) Rot and decay at top of fender pile.
- b) Loose fender pile straps.
- c) It is not known if stub of missing piles exist above mud line.
- d) Snag hazard due to loose mooring lines.
- e) Hanging Steel Rod in board of west pile cap (Photo 20).

Hanging Steel Rod

Photo ST05-20: Pier 4, Pier Deck Soffit

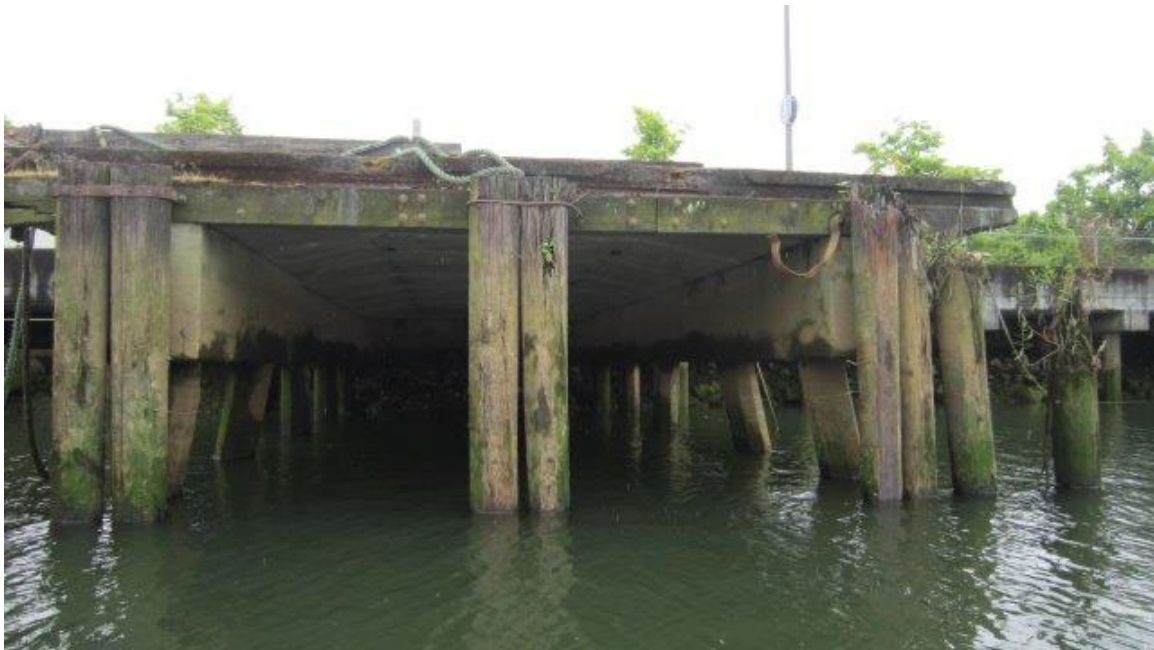
- Several timber fender piles missing or broken with some loose or missing straps. (Photo 22) The tops of several piles appear to be rotted due to weather exposure and subsequent vegetation growth. The body of the piles within and above the splash zone appear to be sound and in good condition. Pressure treatment appears to be in good condition.
- The concrete piles are in good condition except for mortar surface erosion in the wet/dry zone of the piles. The top 6-in of the first pile to the east appears to be field built up and contains rock pockets (Photo 23).

Photo ST05-22: Pier 5

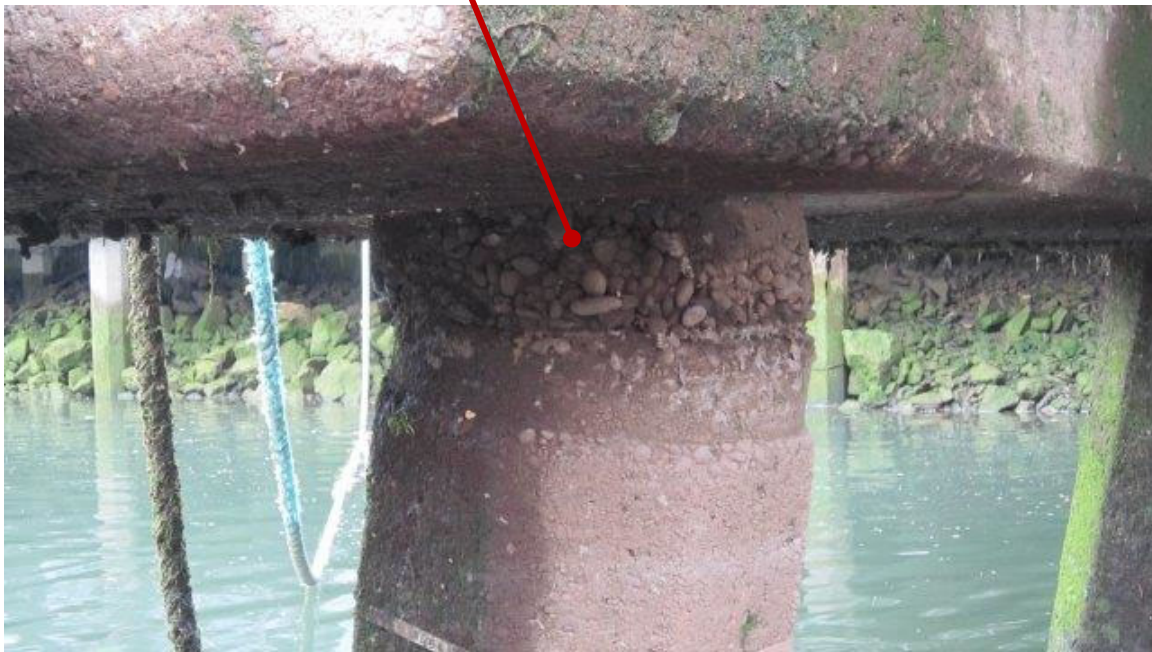
Built Up

Photo ST05-23: Pier 5, Bent 1 East Cap Beam

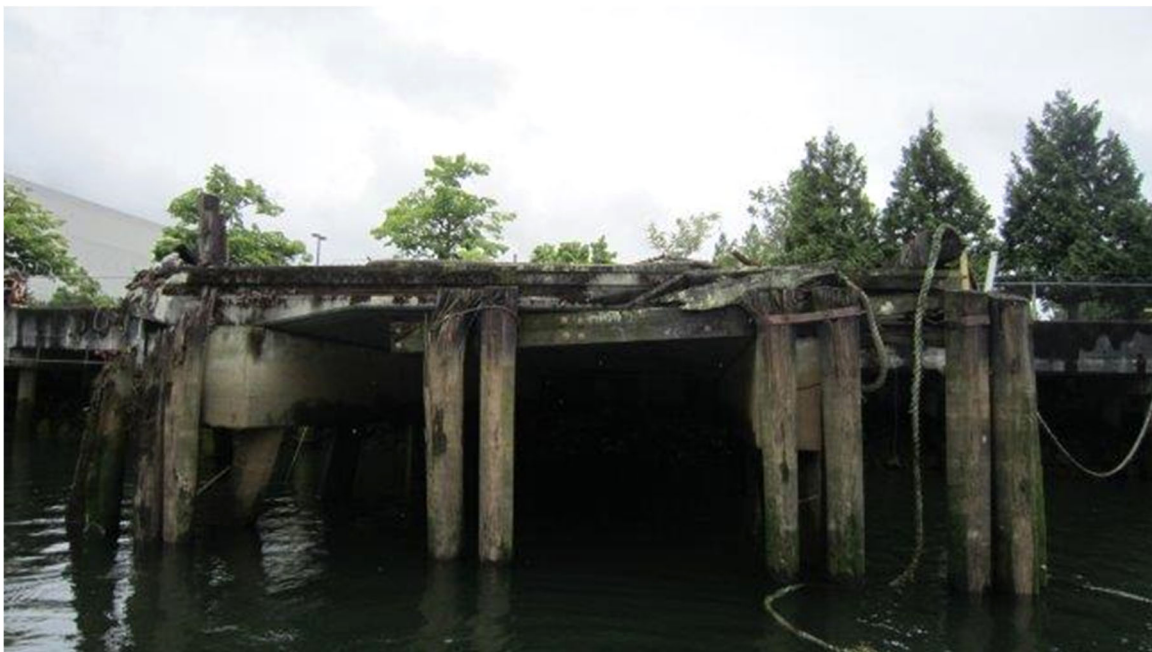
- Most timber fender piles are missing, broken, or damaged. Some with loose, damaged, or missing straps (Photos 26 and 27). The tops of the piles appear to be rotted due to weather exposure and subsequent vegetation growth. The body of the piles within and above the splash zone appear to be sound and in good condition. Pressure treatment appears to be in good condition.
- The concrete piles are in good condition except for mortar surface erosion in the wet/dry zone of the piles (Photos 28 and 29).
- The pile caps are in good condition except for the pile caps are wider than typical dimensions (Photos 28 and 29).
- Concrete pier decks are in good condition except for damage at top west corner with broken concrete and exposed reinforcing steel (Photos 27 to 29).

Photo ST05-26: Pier 6

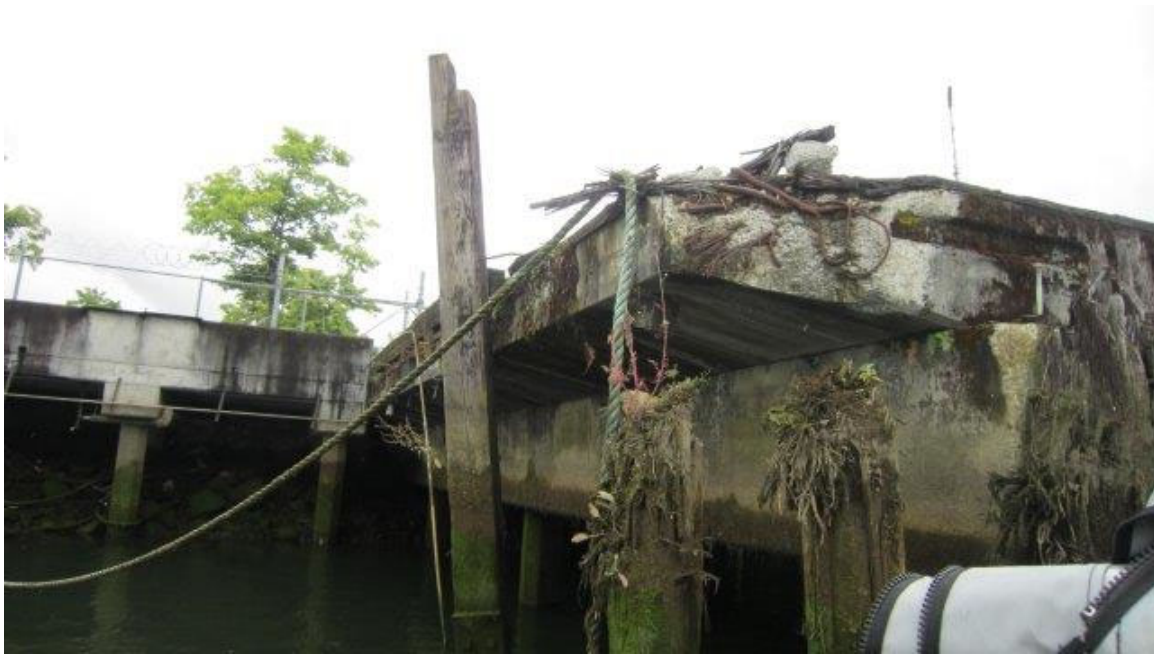
Photo ST05-27: Pier 6, East Side

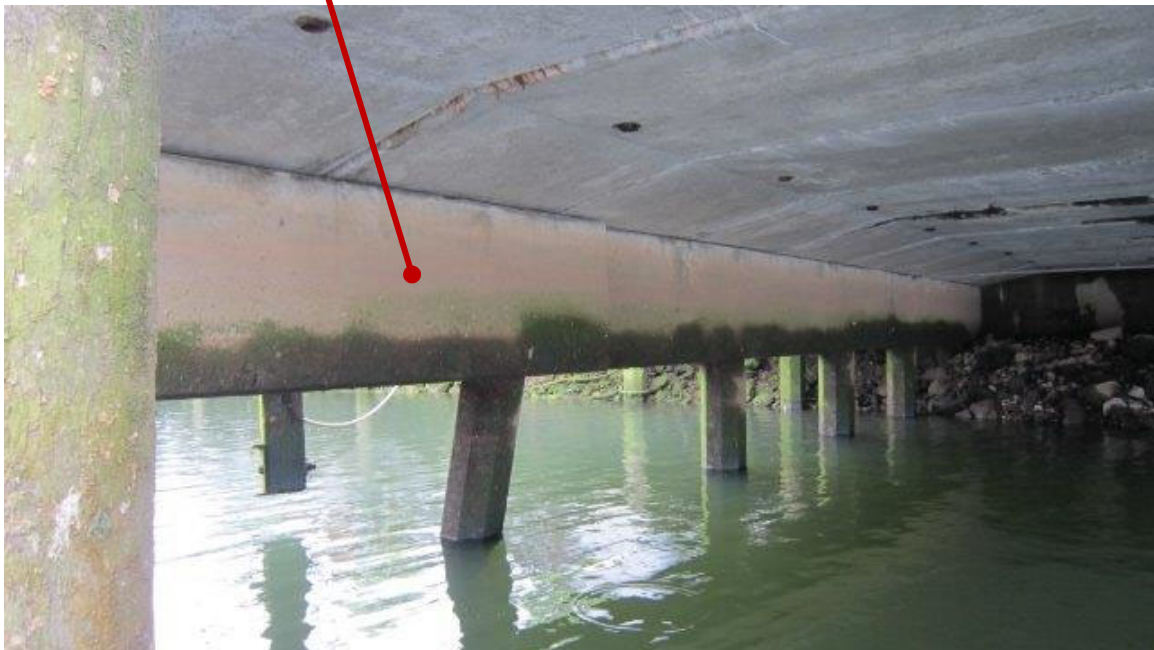
Wider Cap – Over 2 Piles

Photo ST05-28: Pier 6, East Pile Cap

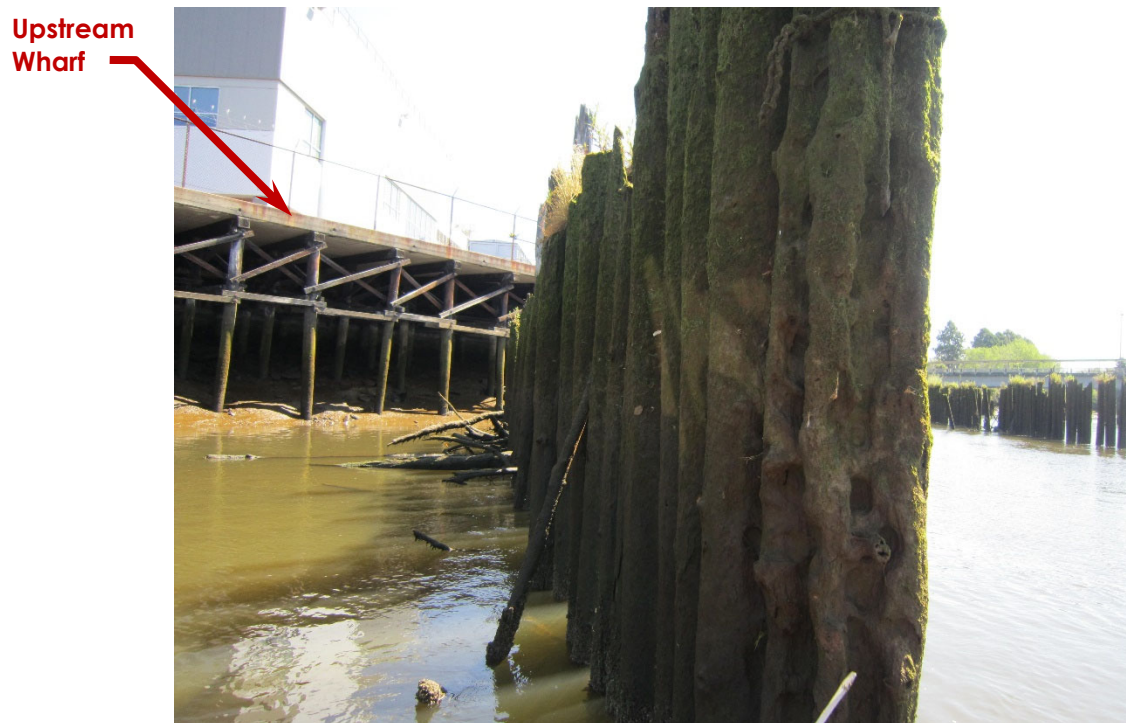
Photo ST07-06: Larger Wharf at Low Tide

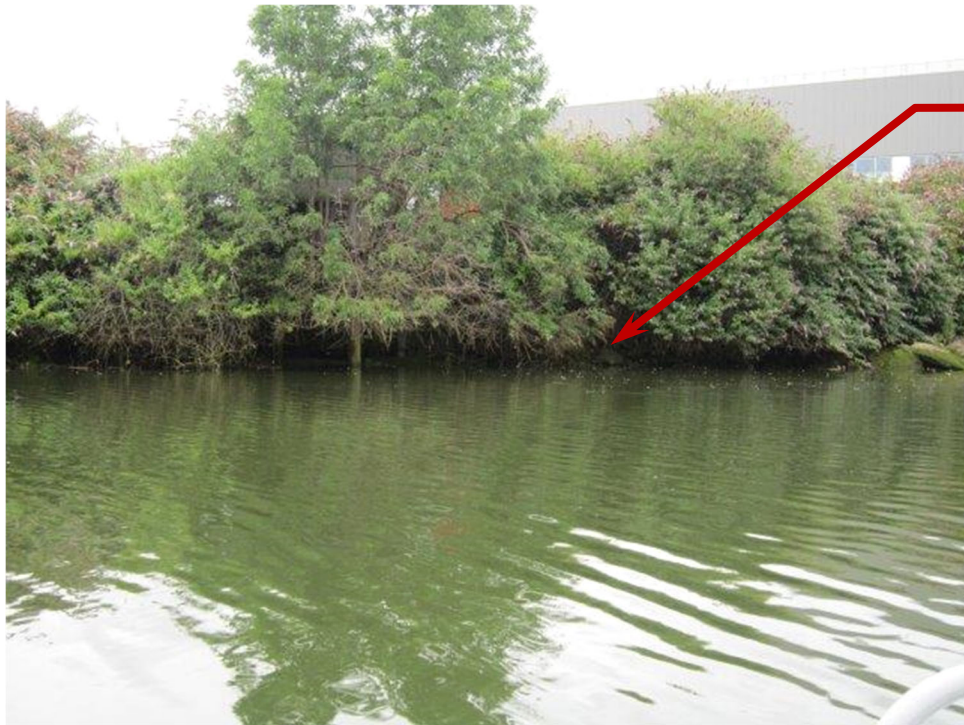
Photo ST07-07: Timber Bulkhead

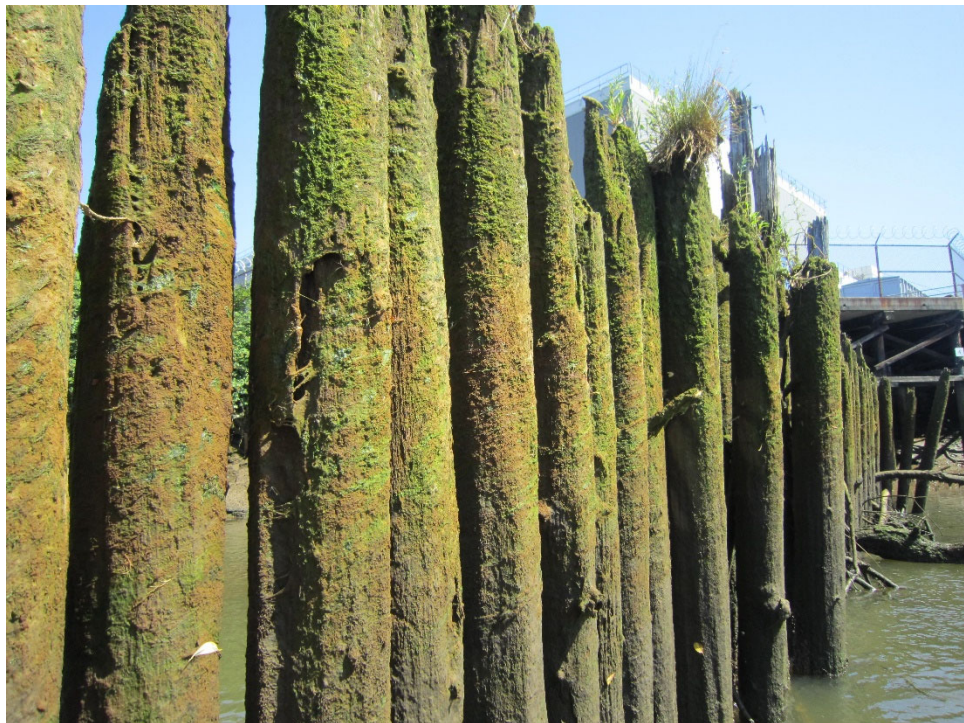
Photo ST07-08: Groin Piles
